ETUDE DE SUIVI DU TRAIT DE COTE  
ET SCHÉMA DIRECTEUR LITTORAL  
DE L'AFRIQUE DE L'OUEST

CASE STUDY OF COASTAL EROSION  
AND SEDIMENTATION  
IN THE GAMBIA

**National Environment Agency**

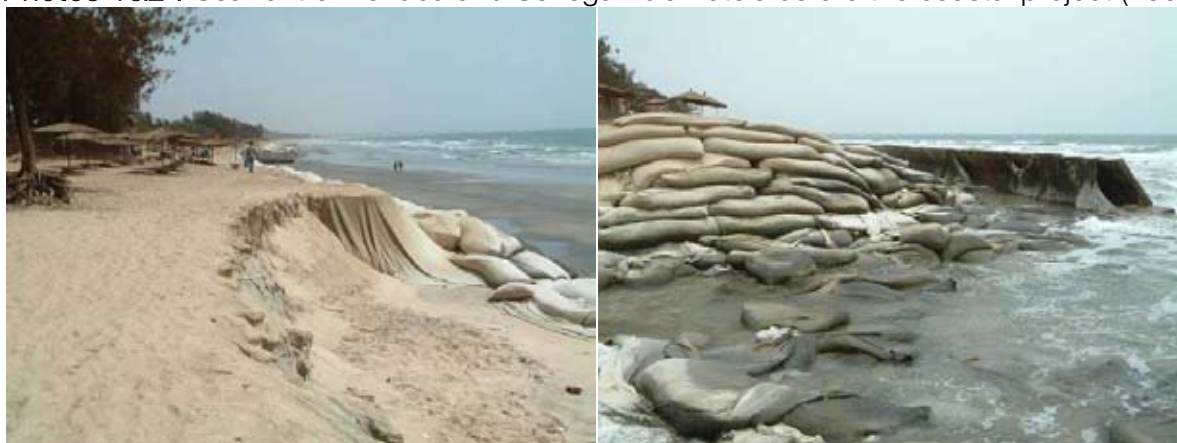
**Photos 1&2 :** Seafront of Kairaba and Senegambia hotels before the coastal project (2000)

The seafront of both Kairaba and Senegambia were with 1 million cubic meters (m<sup>3</sup>) of off-shore sand during the Coastal Protection Project which was completed in March 2004. Based on the as-built final Bathymetric & Topographic survey maps by D. Blankevoort IDC of the Netherlands map dated 20th February 2004, a length of 130.0m-145.0m from the hotel's premises fences to the C+3.0m bench mark was reclaimed. The Coastal Zone Management Unit of the National Environment Agency is charged with the task of monitoring the Gambian coastline including the nourished areas. Occasionally as in April 2005, and October 2005, exceptionally high tides have been recorded which based on our measurements and experiences observed that 15-17meters of the beach parallel to the coastline has been eroded.

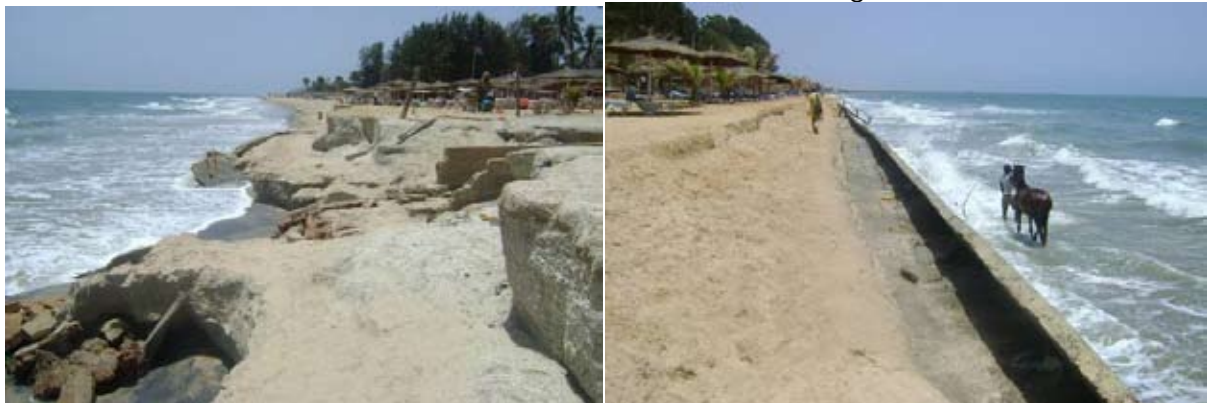
**Photo 4 :** Present situation at the Seafront of Kairaba and Senegambia hotels

Recent measurement shows that nourished beach had decreased from about 150 meters at project completion to 26 meters in February, 2010 to 16 meters on July, 2010. The rate of decrease is estimated to be between 2 to 3 meters monthly, and this rate is expected to accelerate during the rainy season. Powerful wave energy force attacks the beaches and there is the need for devices to minimize the force. Such devices were removed from the Completed CPP implementation because funds were not adequate. In addition, stormwaters from the hotels are channeled through drainage pipes to the beach, and this is contributing to the problem of coastal erosion. The hoteliers have been advised by the Agency to extend those pipes to the high water mark.

It is also observed that deposition only takes when the waves break and dissipate on a wide beach. The situation with Kairaba/Senegambia and Kololi areas is often that the beach embayment is narrow during high tides and hardly any room for waves to break and produce a swash or backwash. Dissipation of waves, followed by deposition of sand will only take place on a wide beach embayment. The Kololi resort area has been nourished very high in such a way that sediment transported to the shores cannot form an equilibrium with the nourish beach sands (NEA, reports, 2007)

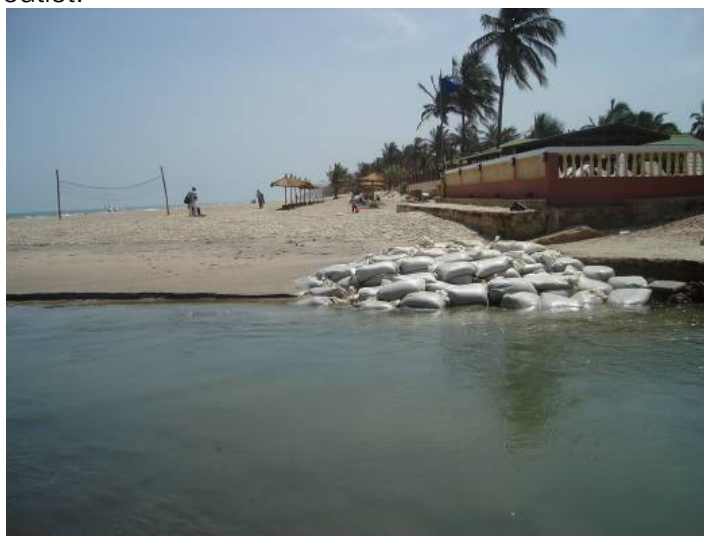
**Photos 5 :** Kotu Stream outlet near Sunset hotel  
(NEA, 2009)

The stream's outlet to the sea is dynamic. It was observed that always in January the outlet is close to the Palm Beach Hotel. However, by the middle of the year, it moves towards the Sunset Hotel. It creates a deep depression at the outlet that makes it difficult for the tourists to cross from one hotel side to the other. The proprietor of the Sunset Hotel undertook preventive measures to save his hotel from the dynamism of the Kotu Stream outlet.

The kotu stream's outlet to the sea is dynamic. It was observed that always in January the outlet is close to the Palm Beach Hotel. However, by the middle of the year, it moves towards the Sunset Hotel. It creates a deep depression at the outlet that makes it difficult for the tourists to cross from one hotel side to the other. The proprietor of the Sunset Hotel undertook preventive measures to save his hotel from the dynamism of the Kotu Stream outlet. This area has been included in this study so that a long-term monitoring and possible intervention could be implemented in the future. The revetment at the Cape point has performed beyond expectations, because the eroded area of the beach has been filled naturally over the past years. However, on one side of the revetment is currently experiencing erosion from 120m to current measurement of 90.3, showing a difference of -29.7m in shoreline shift.

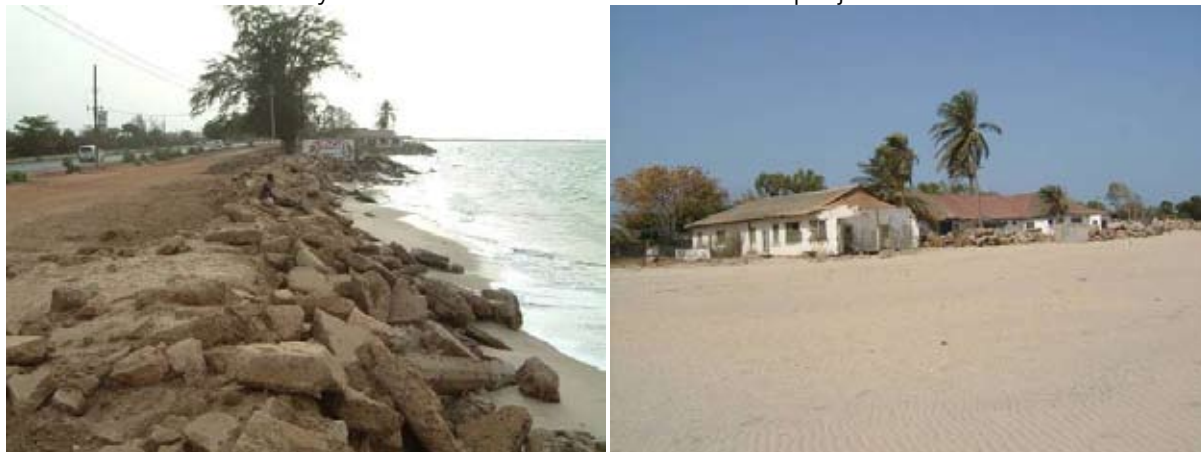
Photos 7 & 8 : Radio Syd area before and after the coastal project

Evidence from multi date digital photographs indicate a change in the beach profile, the seawater is advancing rapidly into the Lagoon and eroding the nourished beach . The inlet to the Lagoon is narrowing down in such a way that more sand is accreting at the edge of the spit and blocking the passage of water movement into the Lagoon.(photos: 11&12)

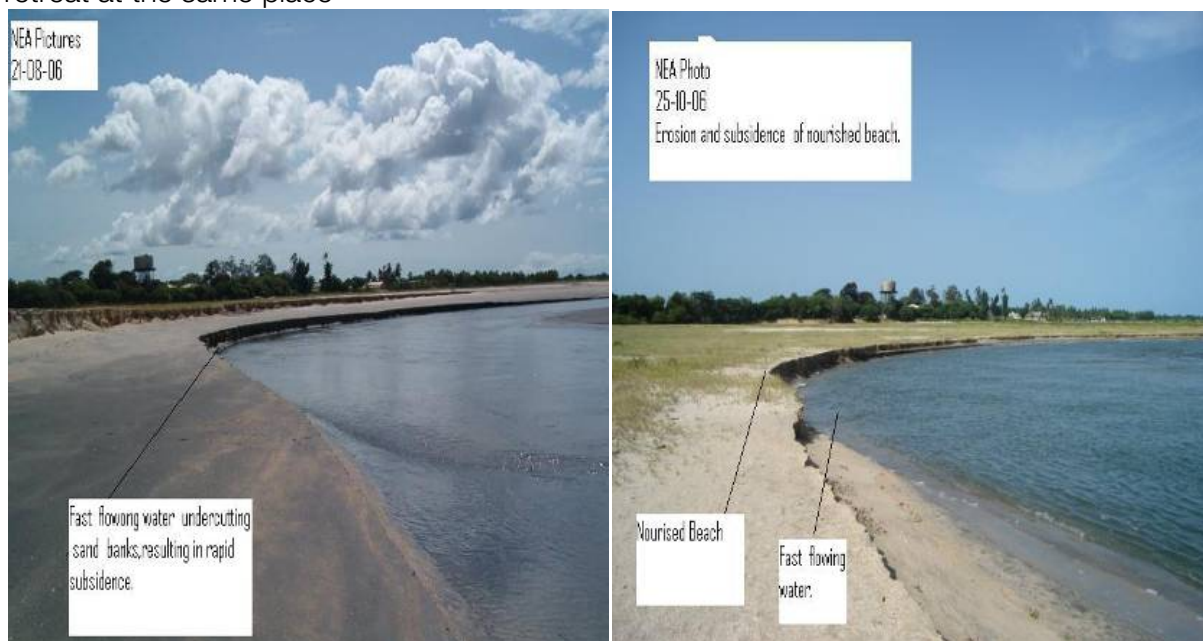
**Photos 11&12 :** Pictures taken at different dates showing signs of erosion and shoreline retreat at the same place

The sand spit parallel to the Lagoon is developing in an eastward direction, however the rapid flow of water flowing across the edge of the sand Spit has interrupted the littoral system, resulting in a break and change in direction of sand deposition from an eastward direction to a Southwest direction. Pictures taken at different date's best explains changes taking place at that area, a measurement of 4 meters was recorded from the high water mark to the sand bank on a narrow beach embayment; this is evidence of shoreline retreat (photos 11 & 12).

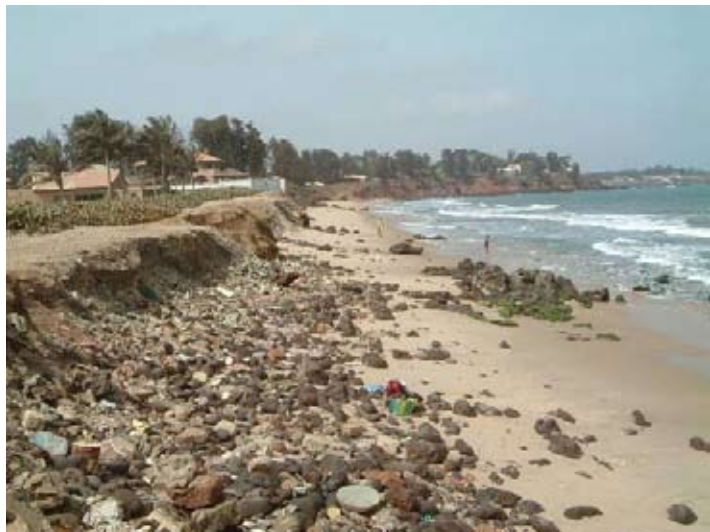
**Photo 19 :** Cape Point revetment before the coastal works  
(Haskoning and NEA 2000/2004)

As part of the Coastal protection works project that was completed in 2004, a new coastal protection strategy was designed and implemented at cape point which consists of a 300 m long rock revetment at the west side and the cape itself and connecting with the northern groin of a 5 groins scheme.

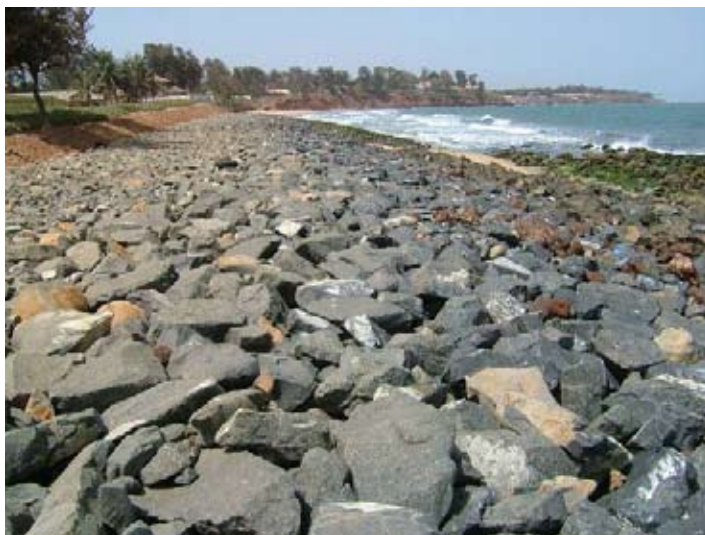
**Photo 20 :** Cape Point after coastal work  
(Haskoning and NEA 2000/2004)

A considerable infill of the new beach pockets was done by nature in less then half a year.
