ETUDE DE SUIVI DU TRAIT DE COTE  
ET SCHÉMA DIRECTEUR LITTORAL  
DE L'AFRIQUE DE L'OUEST

*ETUDE DE CAS EN SIERRA LEONE*

REPORT OF EROSION CASE STUDY:  
SHENGE, PLANTAIN ISLAND  
AND BONTHE.

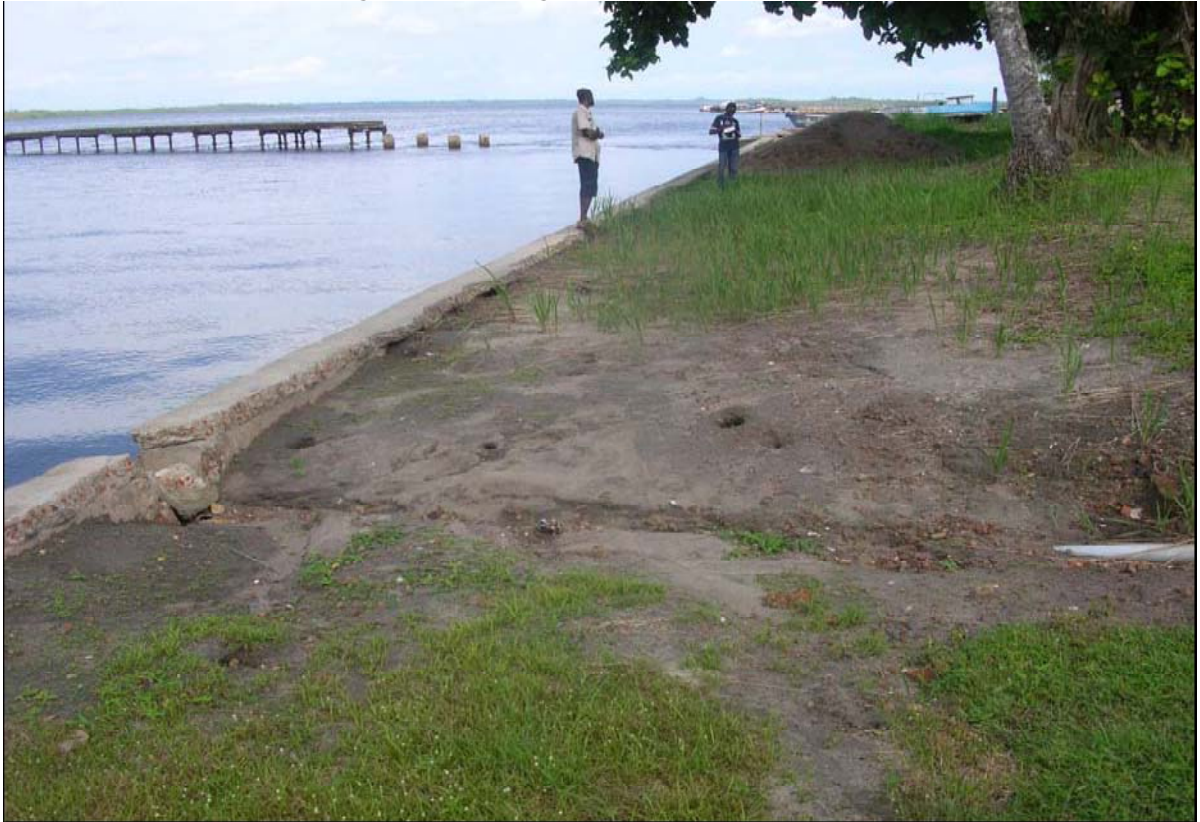
**Figure 3:** Part of the shoreline of Bonthe Town showing the defensive wall constructed to reduce erosion. Now the high tide water goes over this coastal defense barrier.

At Bonthe Island defensive walls against erosion had to be erected to protect the township (figure 3). On the Turners Peninsula the Catholic Mission and some villages on the peninsula had disappeared in the last 100 years. The waterways leading to Sherbro Island are clogged due to heavy siltation thus greatly impeding coastal navigation. The estimated annual sea rise is 0.2cm/yr and the estimated sedimentation rate is 0.5cm-2cm/yr.

The Bonthe Town shoreline was protected by building a defensive wall in the 70s which has now either been seriously eroded or is completely under water at high tide. Important slipways for private companies (PZ, CSE) have been lost. Landing facilities have either been lost or badly damaged. Close to 35 artisanal boats land at Bonthe every day bringing goods

There is urgent need to construct a coastal defense structures around the Plantain Island before further damage is caused on the tiny bit of the Island that is remaining. The Defensive wall at Bonthe should be rebuild/strengthened but more so extended to areas previously not protected and the city had expanded into those northern areas of the Island.

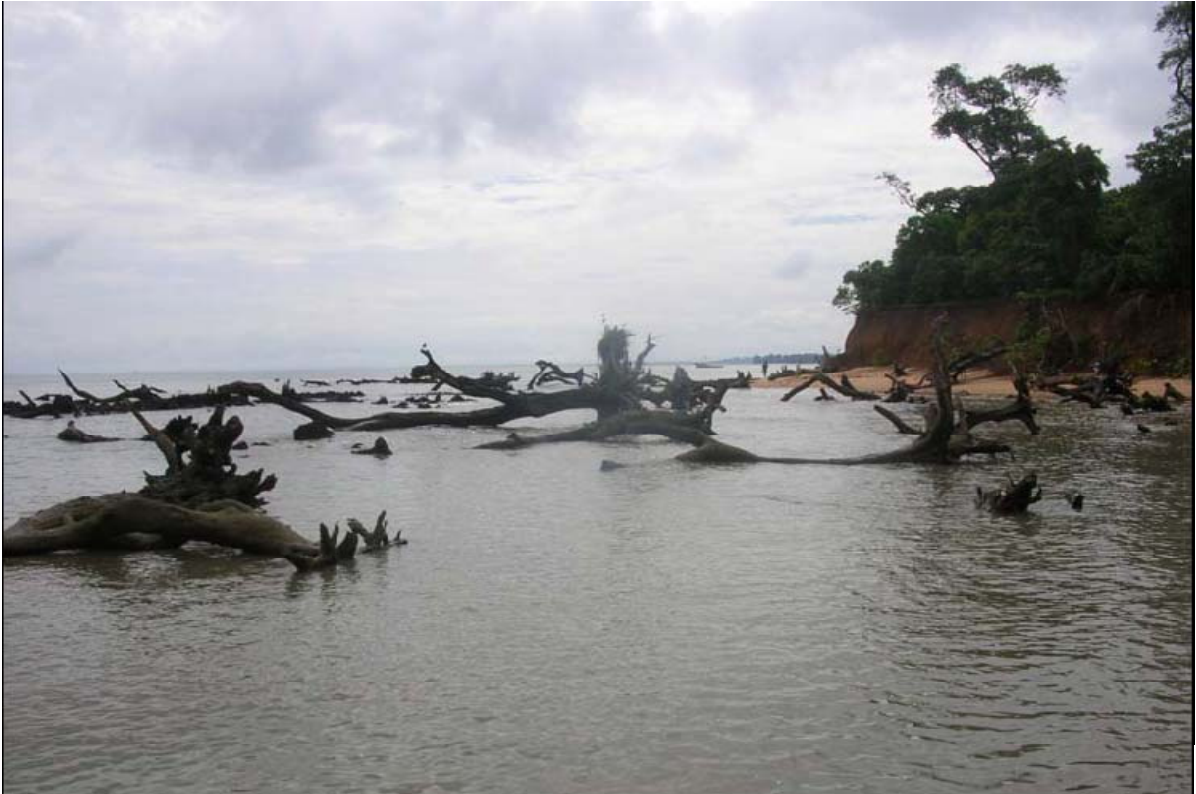
**Figure 6:** Trees uprooted by erosion effects on Plantain Island. Fallen trees were part of the Island

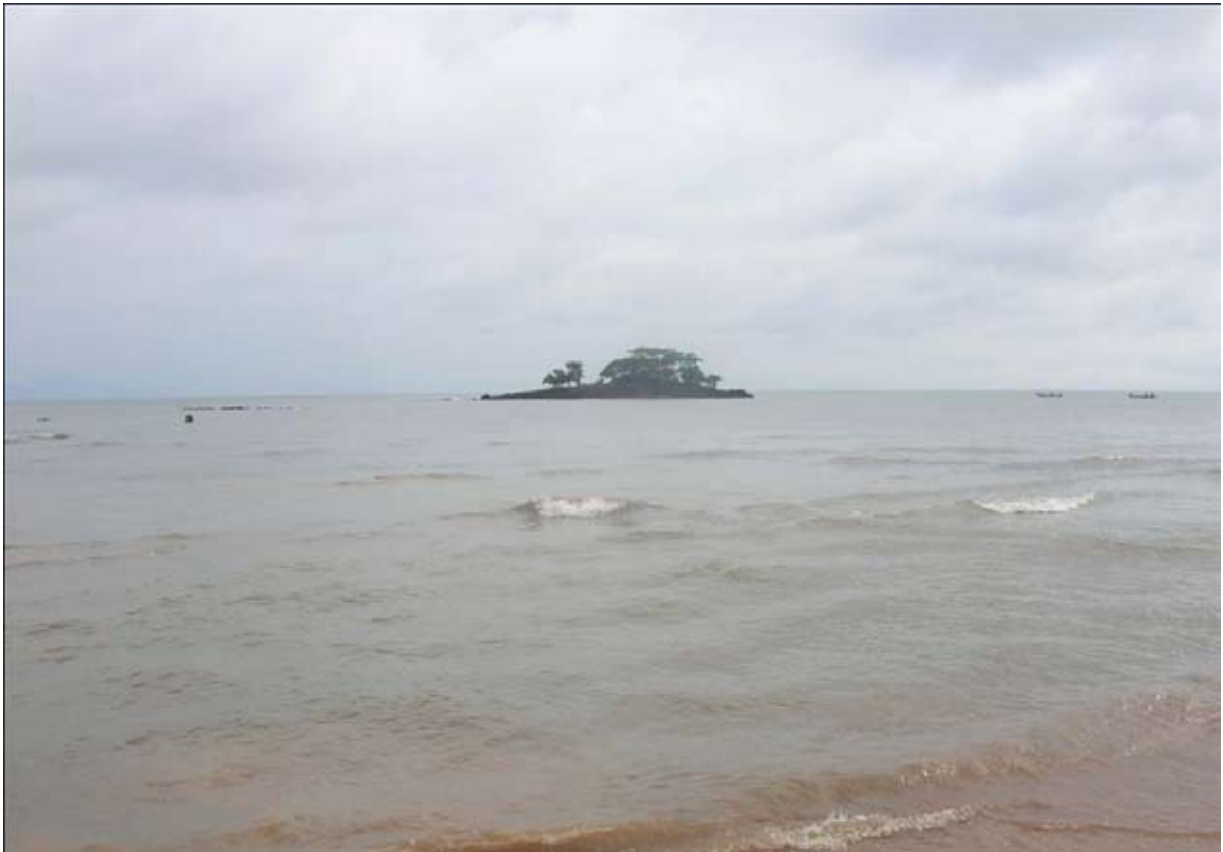
**Figure 7:** Former Slave Pen now cut off from main plantain Island and most of its remains under water

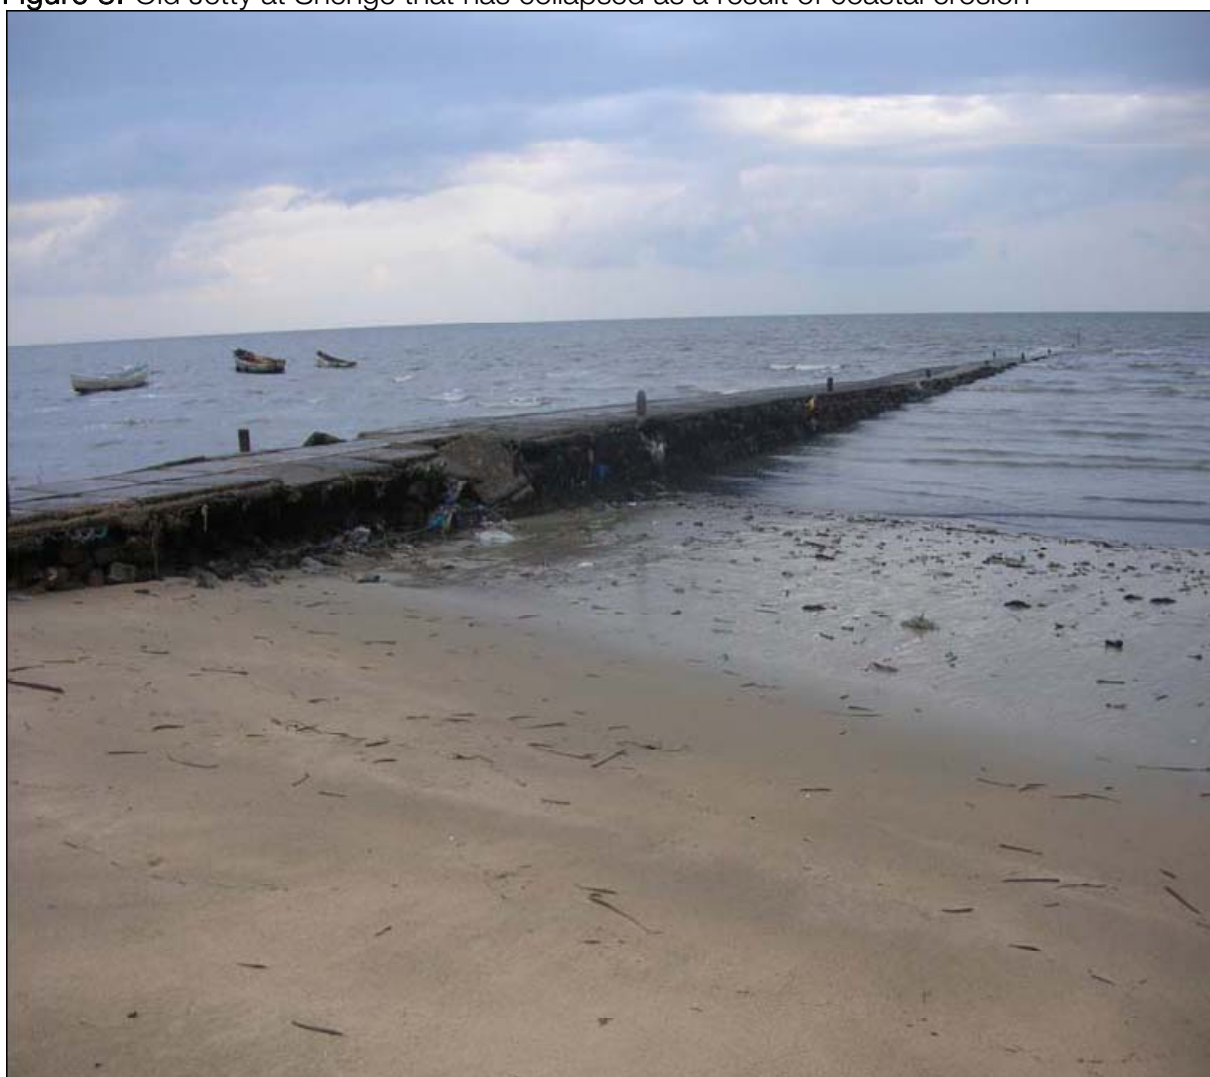
**Figure 8:** Old Jetty at Shenge that has collapsed as a result of coastal erosion

Shenge has a landing facility built in 1989/90. The ramp (150m long and 4m wide) is supported by three layers of Maccaferri gabions of average thickness of 2m. Due to the action of the waves, this jetty has almost collapsed. A new jetty is being constructed under the African Development Project (AFDEP). This facility is under less threat from coastal erosion at its southern side but more prone to erosion impacts from the northern side, so a retainer walls have been erected (E.T. Ndomahina).

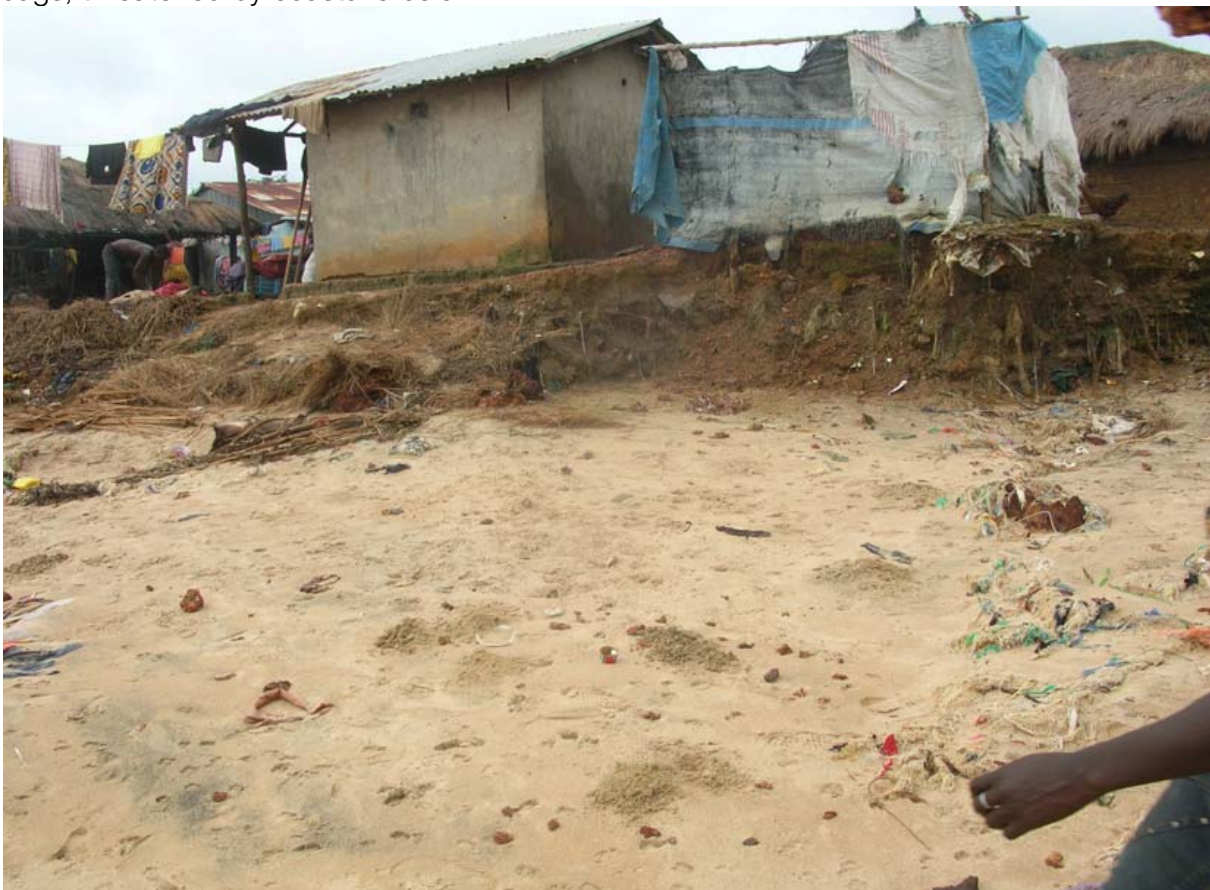
**Figure 11:** one of the best houses on the Island with a fence made from sticks and rice bags, threatened by coastal erosion

There was no coastal defense system in place for this small Island and it is believed that if nothing is done to protect the remaining small landmass inhabited by this fishing community, the whole Island could be lost into the sea. Local fishermen were aware of this threat and reported that this was the main reason why they were mostly living in make shift houses which would not be expensive to rebuild when washed away by waves (Figure 11 and 12).

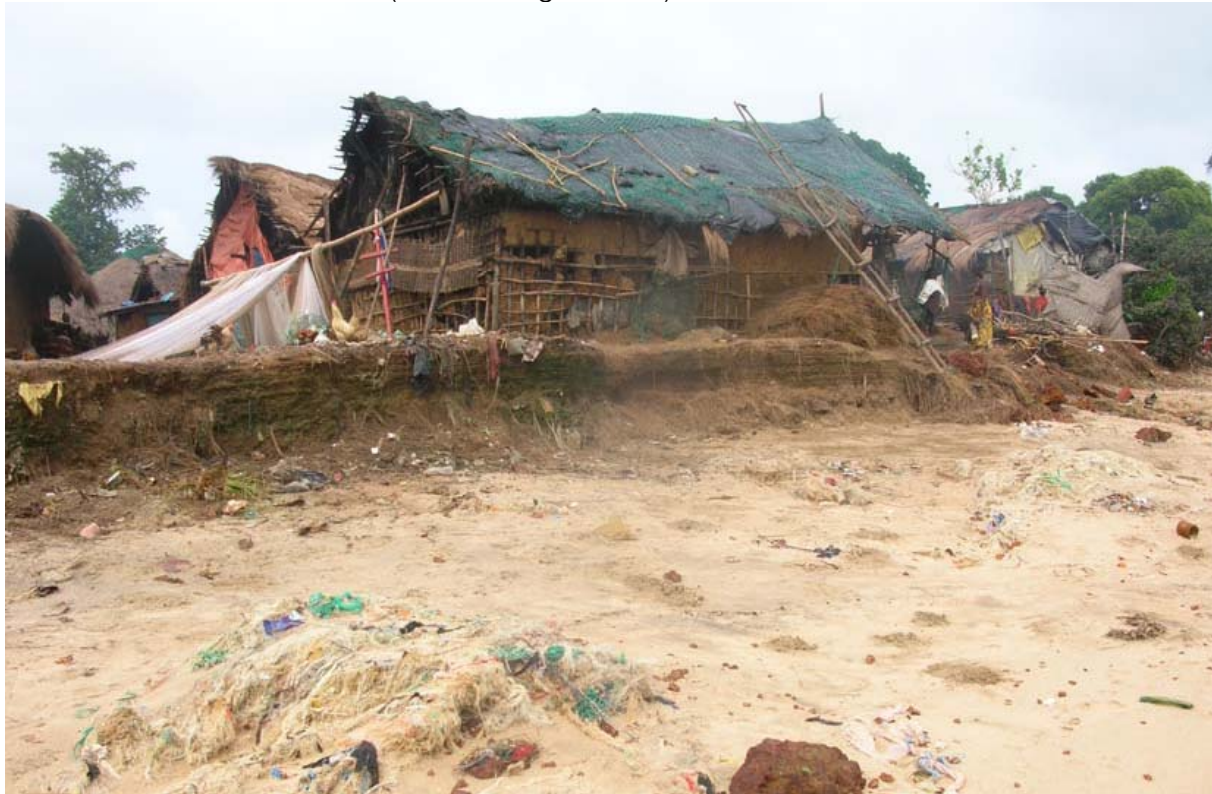
**Figure 12:** most common type of housing units found on the Island. The fishermen can rebuild the house if broken down by erosion as most of the building materials are obtained from the natural environment (forest and grassland)

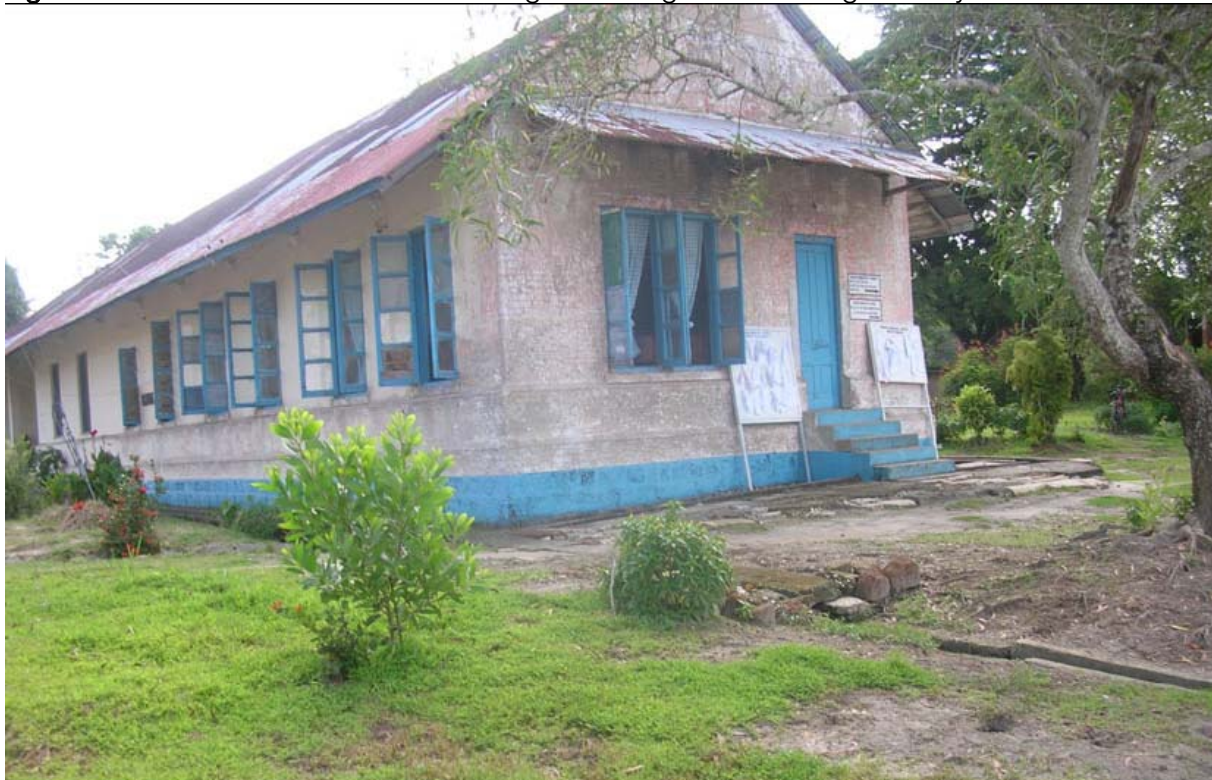
**Figure 13:** Colonial Government Building where high tide water goes very close now

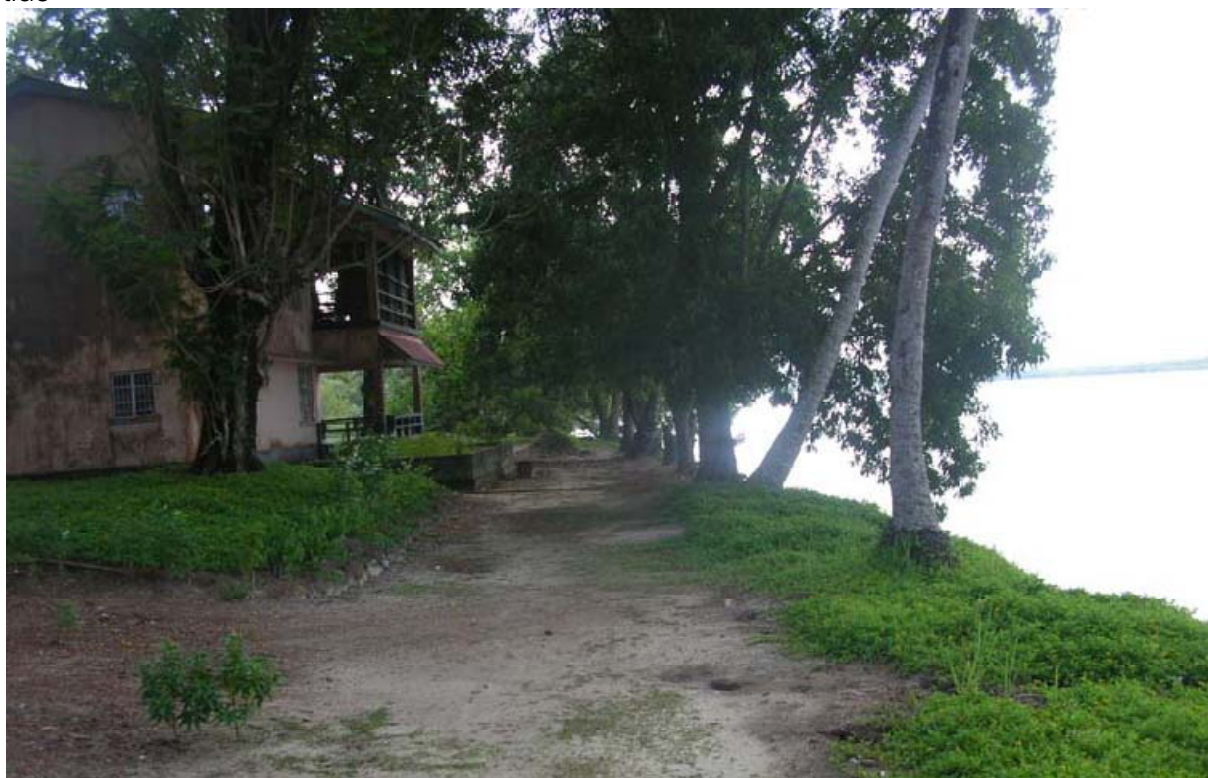
**Figure 14:** A residential block built in the 50s now threatened by flooding, especially at high tide

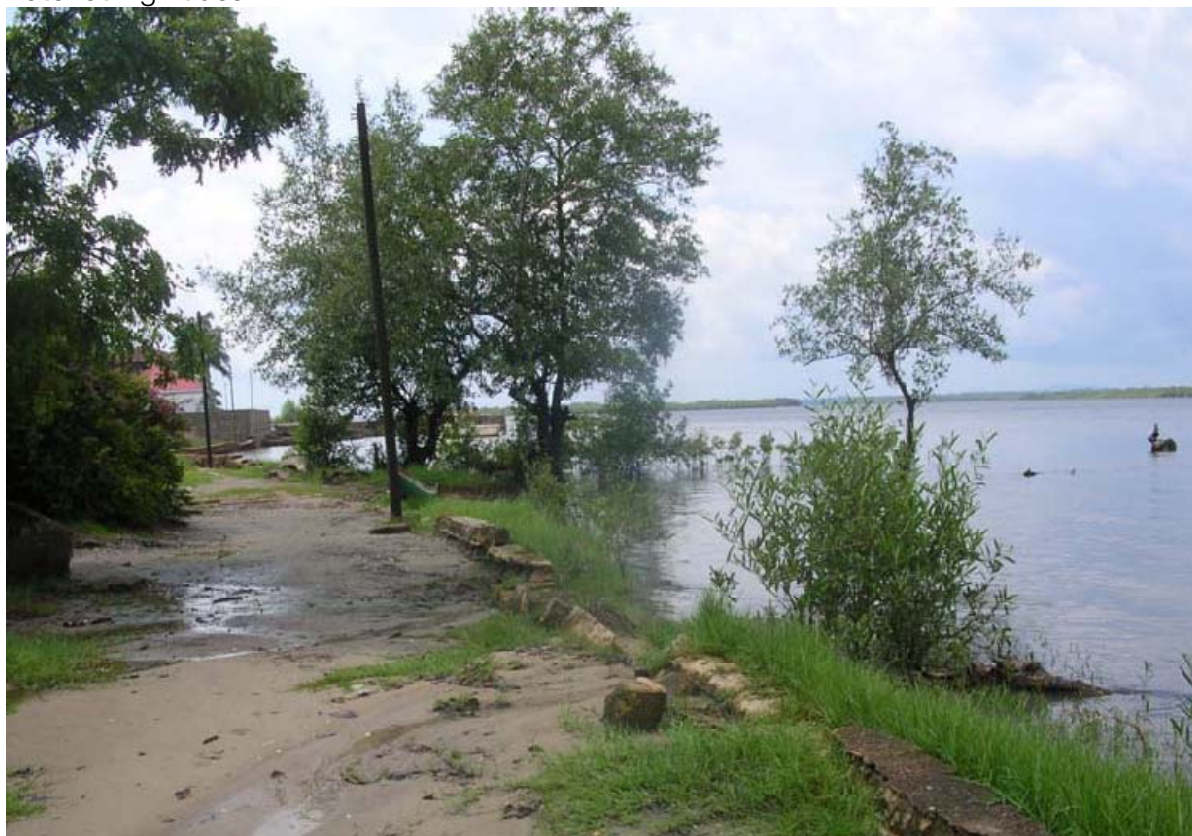
**Figure 15:** Defensive wall build in the 50s no longer protect the coastline as this wall is under water at high tides

On the contrary, the housing facilities at Bonthe Island and Shenge were much stronger and not much threatened by coastal erosion. This is apparently because at Bonthe, a coastal defense wall was built to protect most part of the township adjacent to the shoreline. On the northern side of the Township, erosion was recorded to be much higher and in areas where the defensive wall still resists erosion, the areas are flooded including the wall itself.

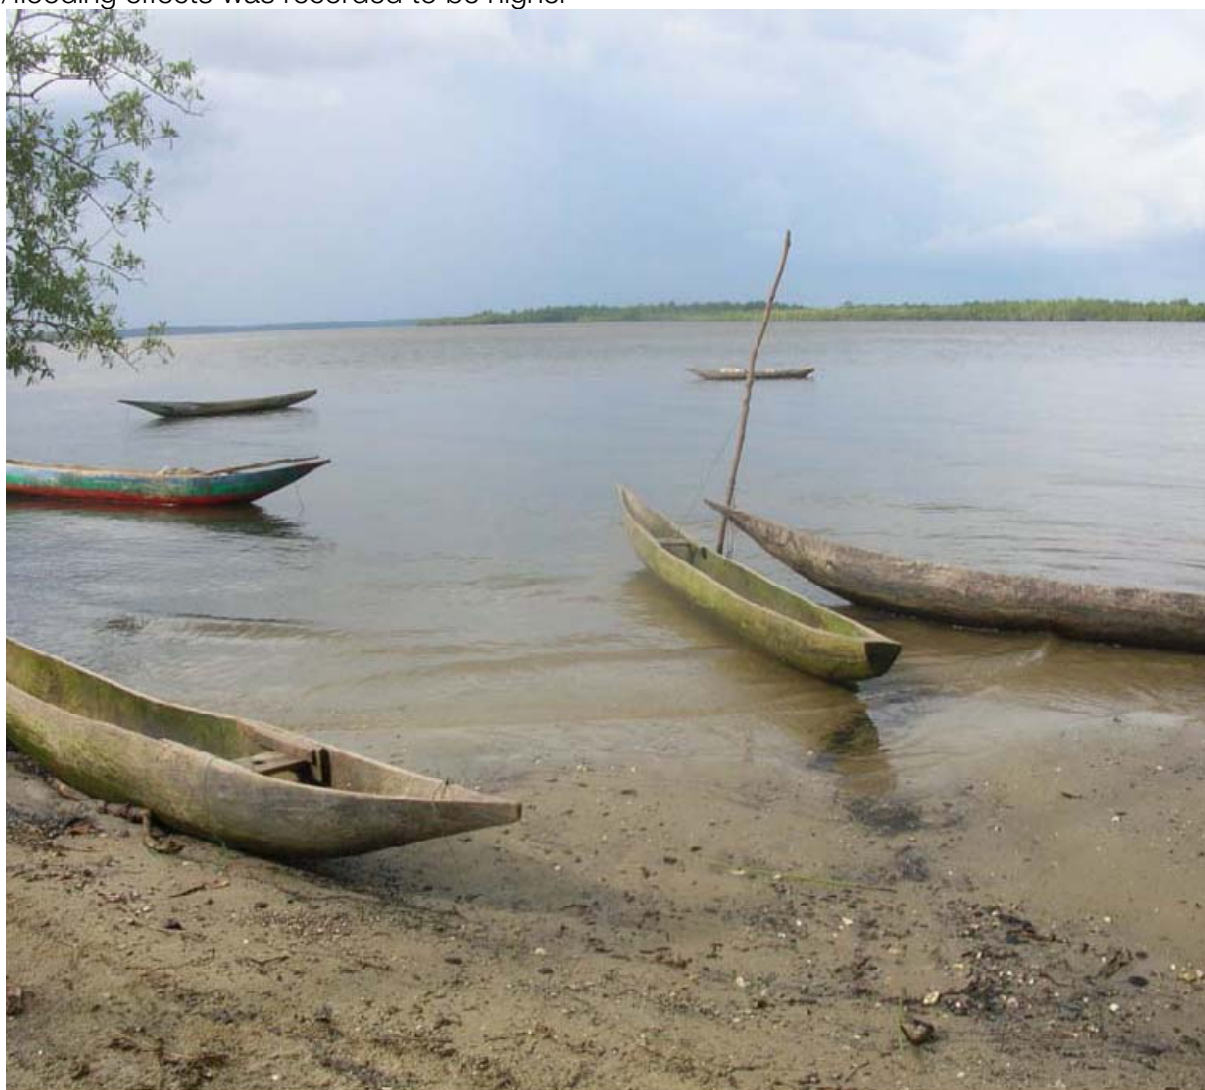
**Figure 16:** Northern side of the Island where no wall was constructed- erosion rate /flooding effects was recorded to be higher

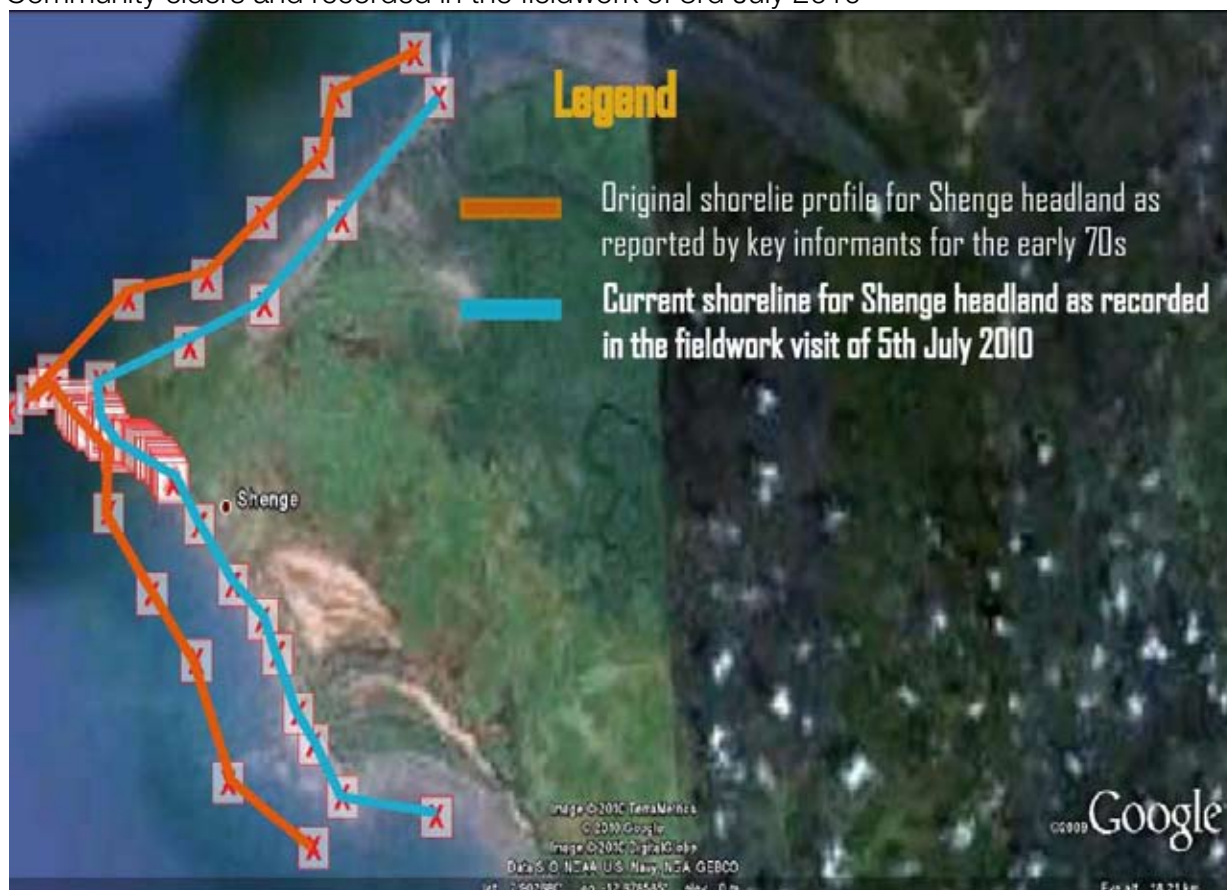
**Figure 19:** Original and current shoreline profiles of Shenge as reported by Village Community elders and recorded in the fieldwork of 3rd July 2010

Coastal erosion is roughly uniform along the northern side and lower southern side of the Shenge headland, at the tip of the headland (Shenge Town) and towards Tisana village in the southern end of the Peninsula (Figure 13), erosion rate was reportedly/recorded to be slower.

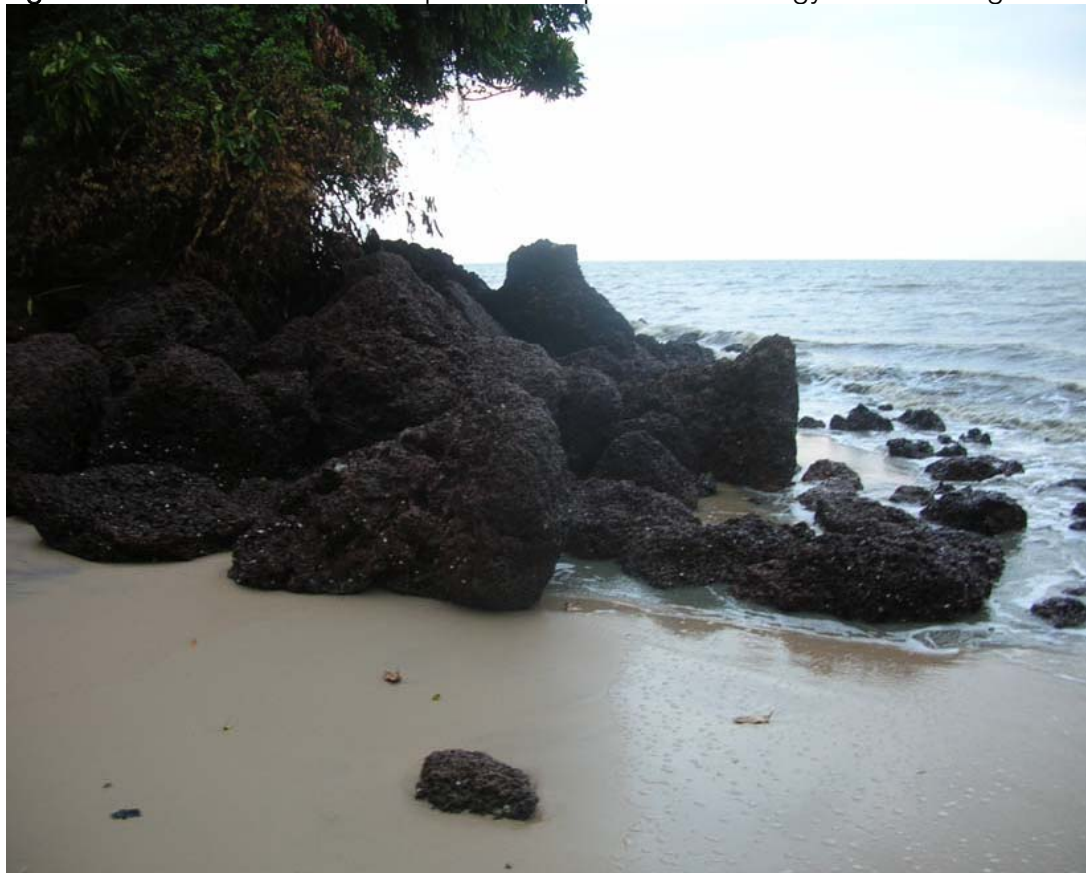
**Figure 20:** Laterite rocks outcrops that dampens wave energy before hitting the shoreline

It was observed during the participatory mapping exercise that areas along the shoreline that are rocky recorded slower erosion rates relative to sandy silt and clay shoreline areas (Figures 20 - 23). Similarly, at some point near the Shenge Township, a protective wall was built in 1989 which has also contributed to the slower rate of erosion close to the tip of the Shenge headland.

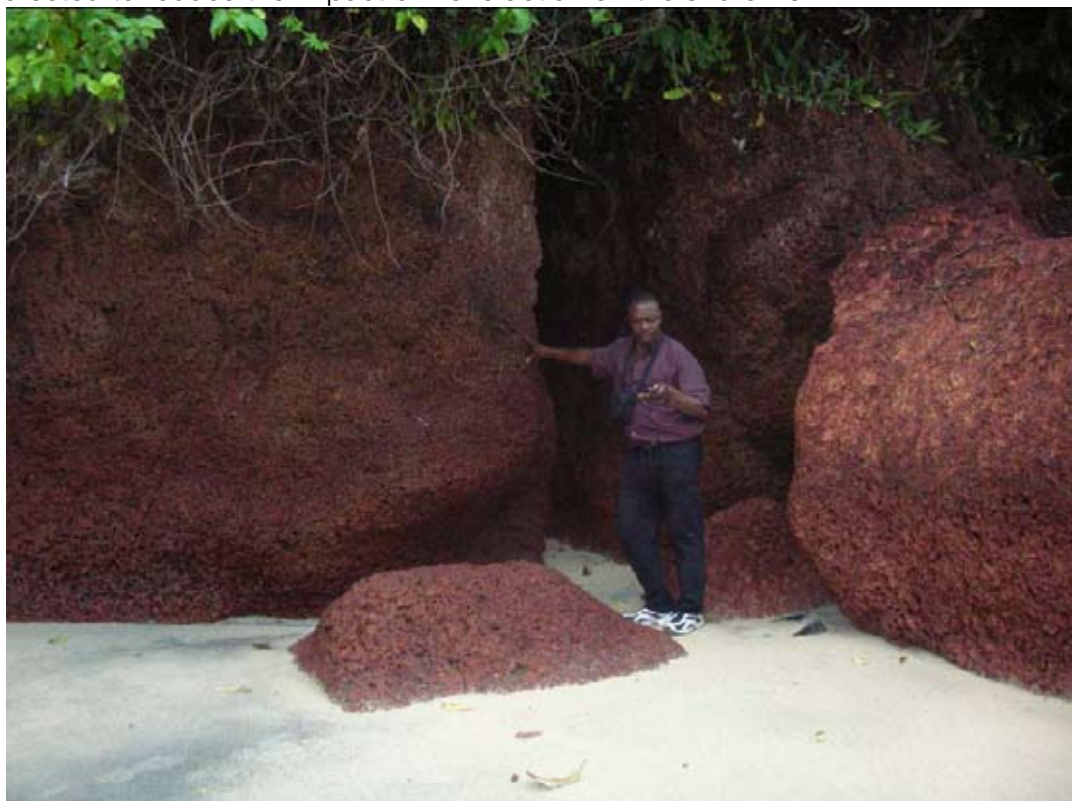
**Figure 21:** sandy shore suffering greater erosion impact. Coastal defense wall had to be erected to reduce the impact of wave action on the shoreline

Most of the shoreline along the Shenge Peninsula was either sandy, silt, clay or a mixture of all these at various proportions, thus the relatively uniform erosion rate recorded all along the shoreline except in at the rocky tip and point where the protective wall is constructed (Figs21).

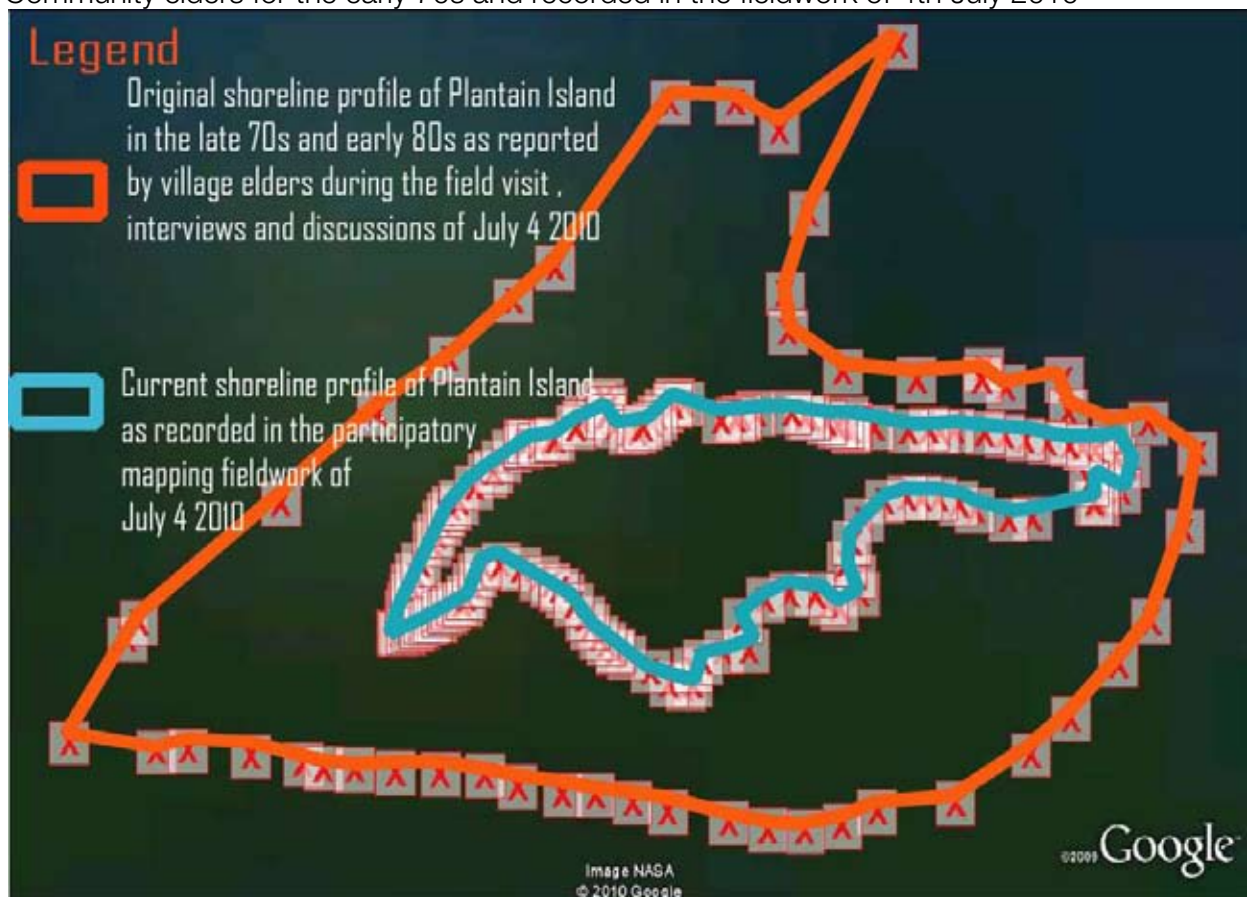
**Figure 24:** Original and current shoreline profiles of Plantain Island as reported by Village Community elders for the early 70s and recorded in the fieldwork of 4th July 2010

The rate of erosion at Plantain Island was very high all around the Island except on the north eastern tip where laterite rock outcrops slow down the rate of erosion. Vegetation cover on the Island do not seem to deter the erosion rate at all as could be seen by the remains of trees uprooted by the phenomenon littering places that used to be part of the Island landmass (Figures 25 -27).

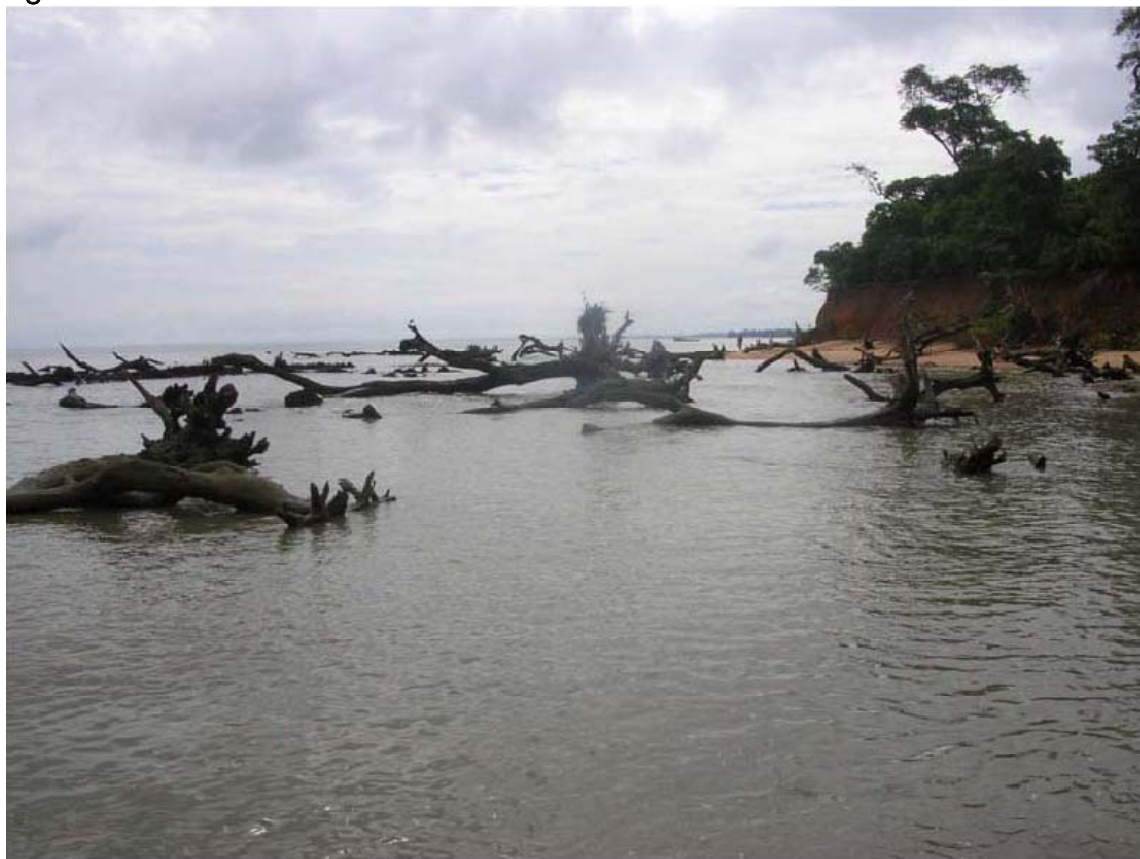
Figure 25: South western end of the Island

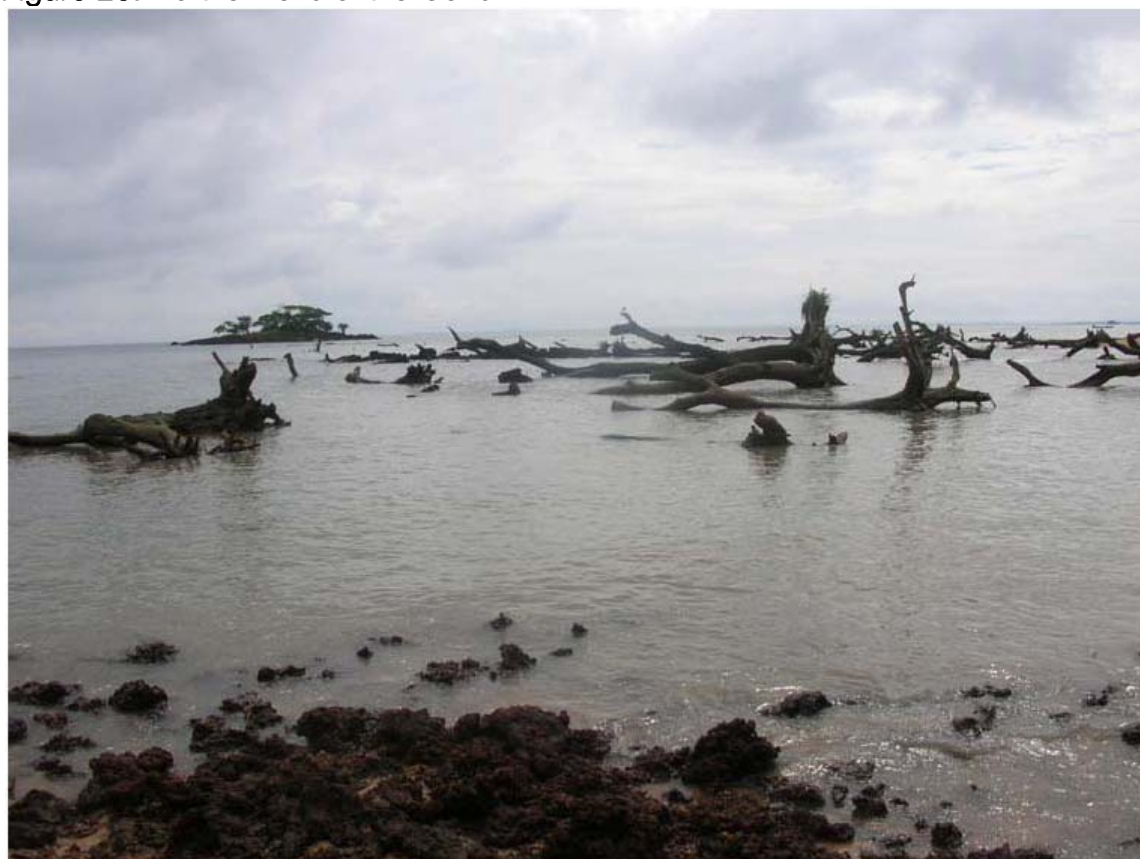
Figure 26: Northern end of the Island

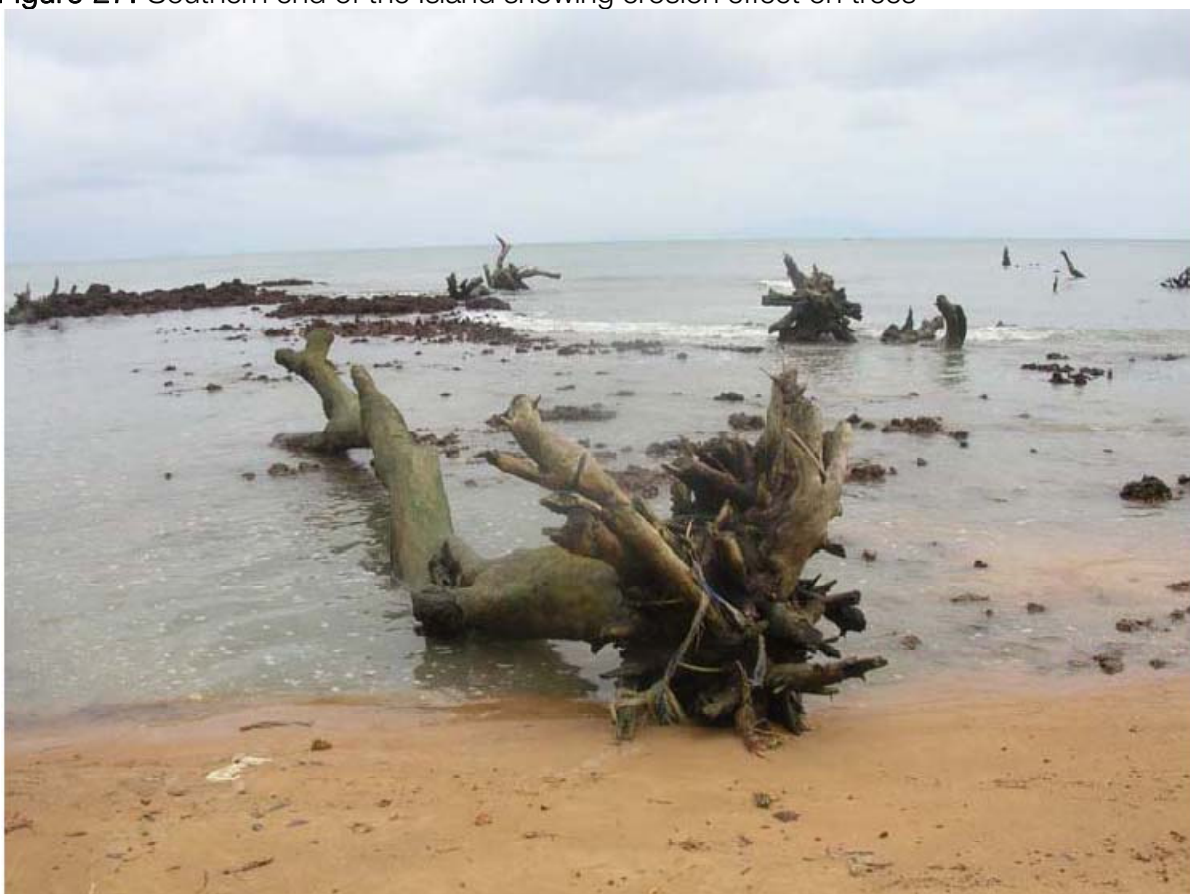
**Figure 27:** Southern end of the Island showing erosion effect on trees

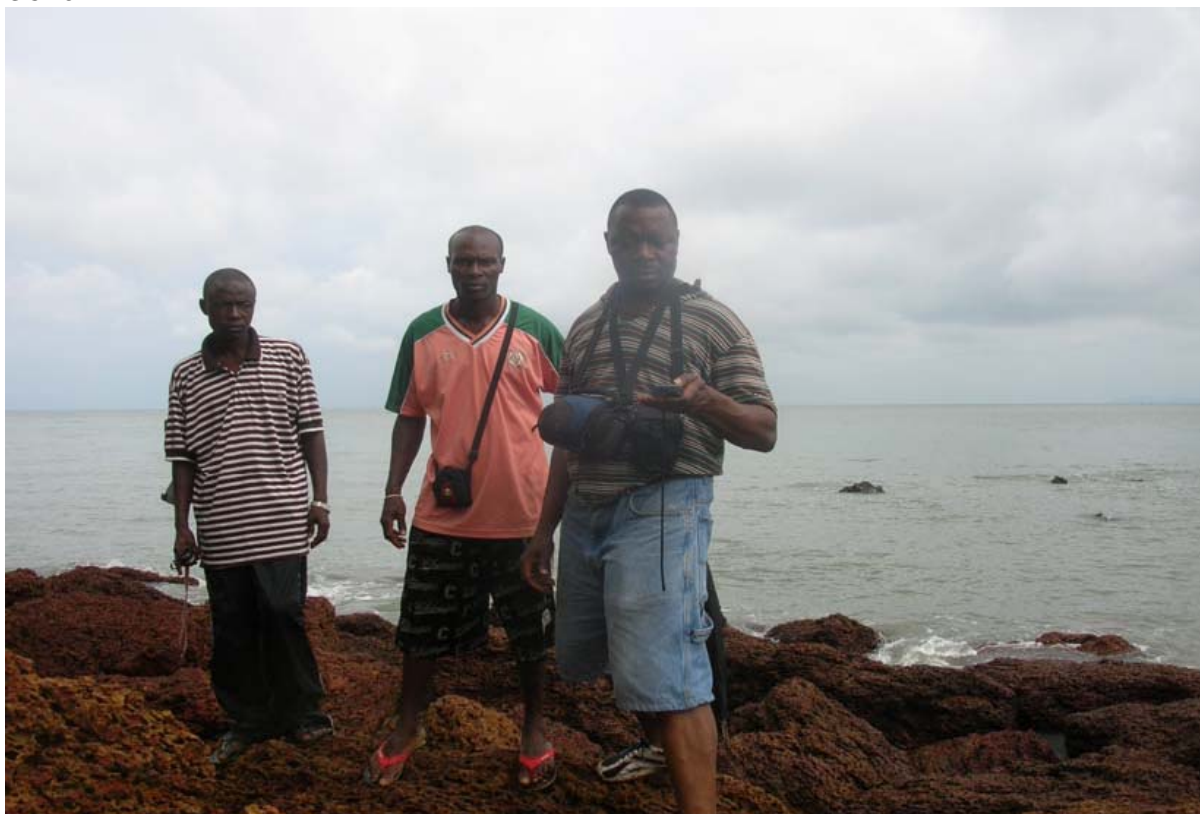
**Figure 28:** Lateritic rock outcrops slowing down erosion at the north-eastern side of the Island.

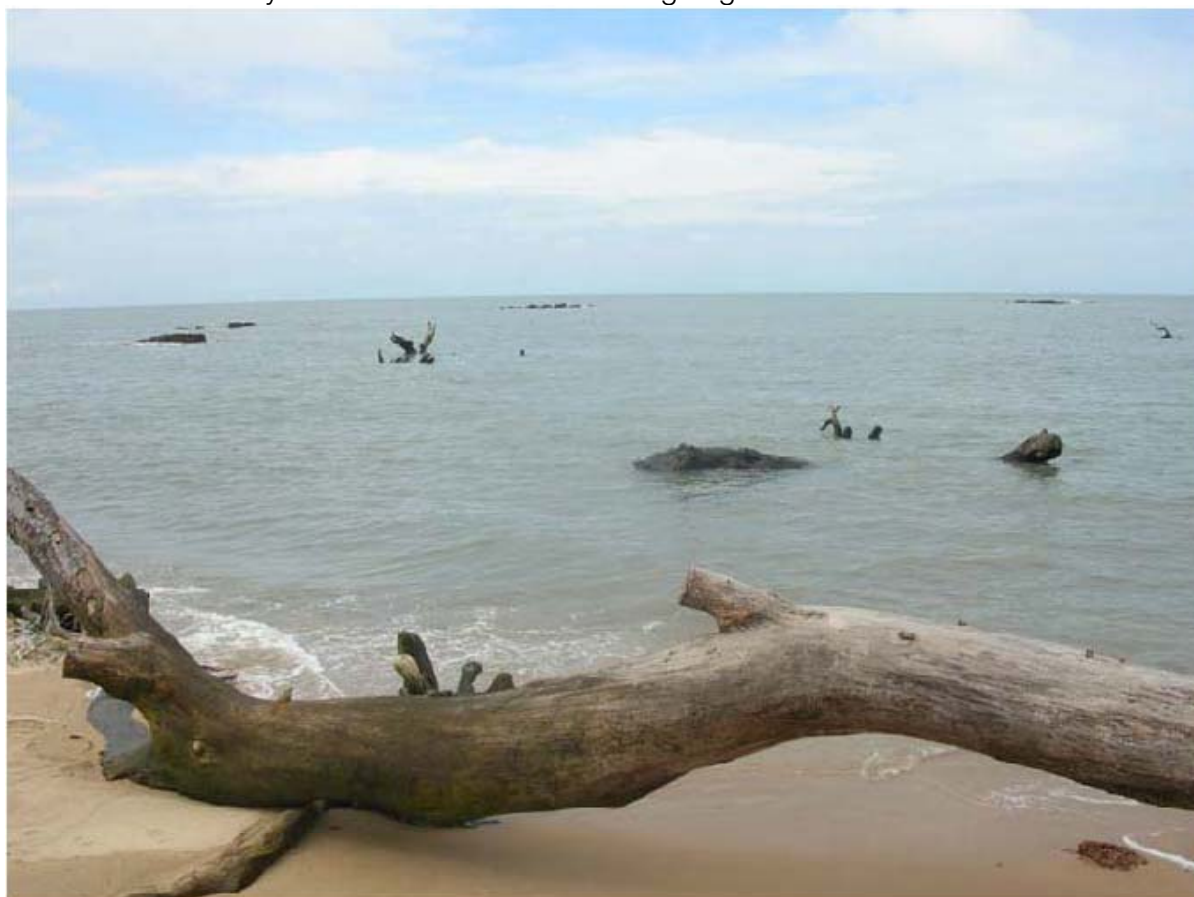
**Figure 29:** Digital photo from current shoreline of Plantain Island showing land marks at a distance identified by local communities as marking original shoreline in the 70s.

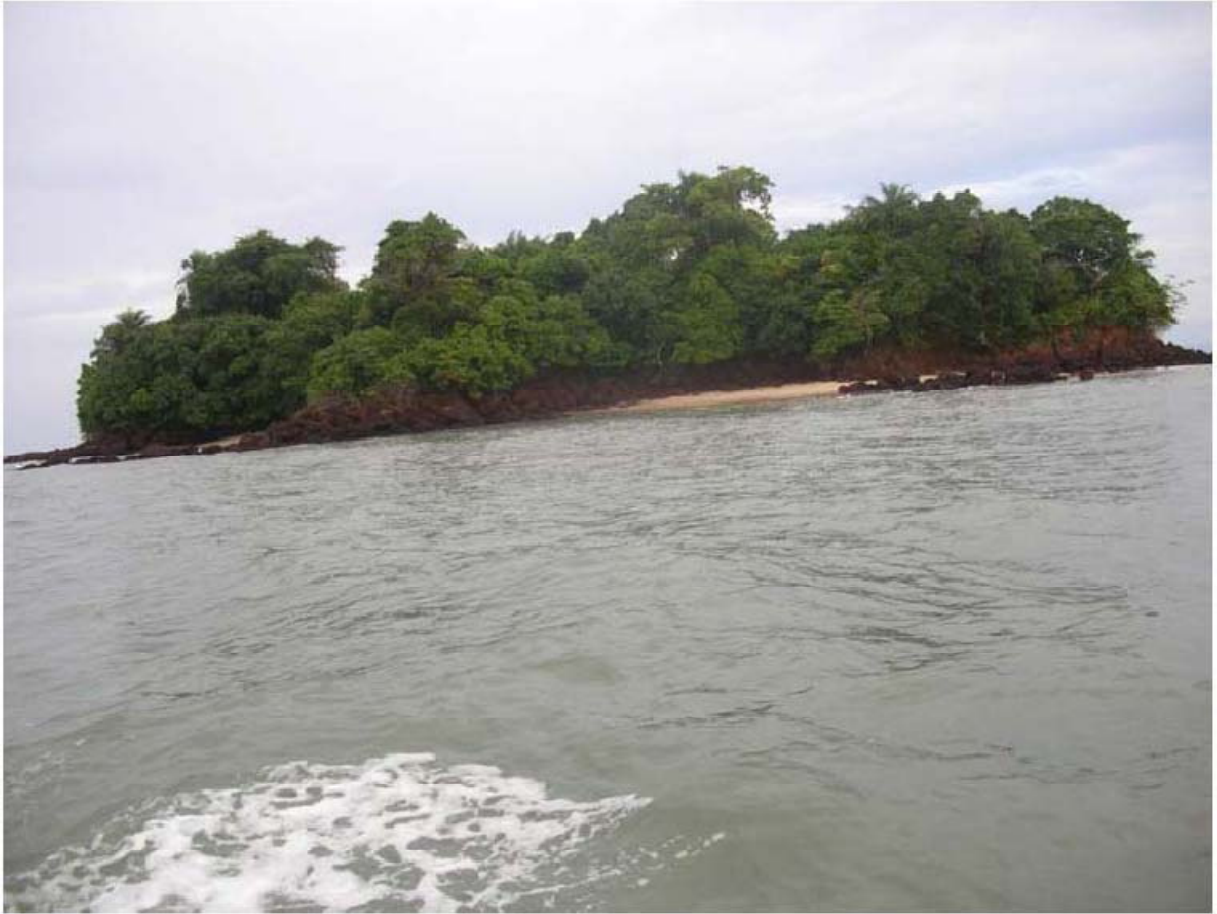
**Figure 30:** Monkey Island reported by key informants to be originally part of the Shenge mainland in the early 60s. the Island is now over 300 meters away from the Shenge mainland.

On the other hand, monkey Island which is much smaller than Plantain Island has resisted rapid erosion over the same period because it has laterite rocks on the shoreline all around it (Fig. 30).
