ETUDE DE SUIVI DU TRAIT DE COTE  
ET SCHÉMA DIRECTEUR LITTORAL  
DE L'AFRIQUE DE L'OUEST

*ETUDE DE CAS EN SIERRA LEONE*

REPORT OF EROSION CASE STUDY:  
SHENGE, PLANTAIN ISLAND  
AND BONTHE.

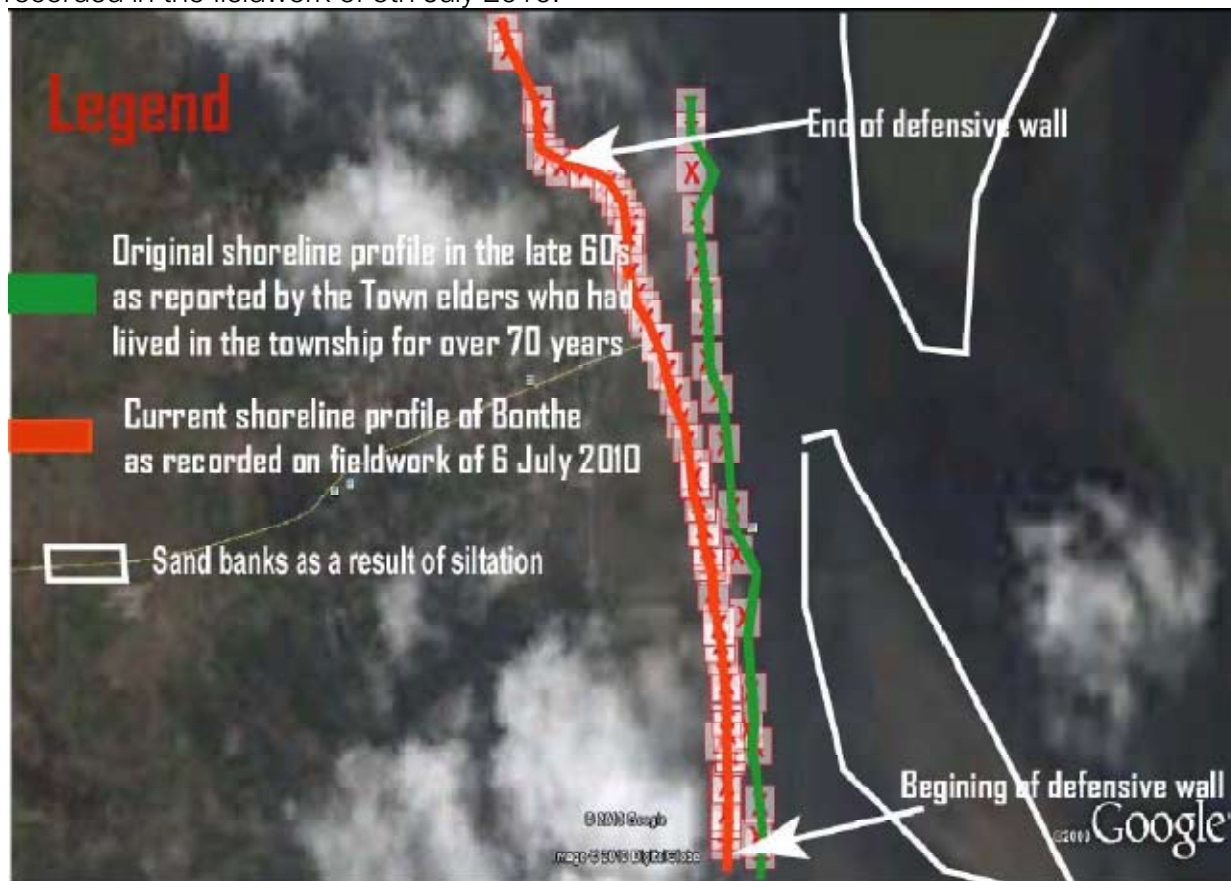
**Figure 31:** Original and current shoreline profiles of Bonthe Township in the Sharbro Island plotted on Google earth image as reported by Village Community elders for the 60s and recorded in the fieldwork of 5th July 2010.

At Bonthe Town, the shoreline profile change between 1950s and 2010 suggest a higher erosion rate at the north than the South. This could be as a result of the fact that the coastal defensive wall constructed along the southern end of the Island.
